Thermal shock cleavage of silicon (111) thin crystals

T. S. Savage, P. Xu,^{a)} and L. D. Marks

Center for Surface Radiation Damage Studies, Department of Materials Science and Engineering, Northwestern University, Evanston, Illinois 60208

Clean thin samples of silicon (111) have been irradiated by 350–400 ns dye-laser pulses of 590 nm radiation under ultrahigh vacuum (UHV) conditions. Results obtained using a UHV transmission electron microscope on the thermal shock cleavage of these samples are reported. Classic cleavage along {111} planes was observed at relatively low fluences (less than 0.04 J/cm²). The observations on the sample morphology before and after laser irradiation demonstrate that under the conditions that yield to cleavage, there is no long range diffusion of point defects and there is no tendency for the cleavage to occur at pre-existing defects. Although in some cases, cleavages occur at locations that are logically weak, in general, there appears to be no correlation between the cleavage sites and the three-dimensional crystal structure.

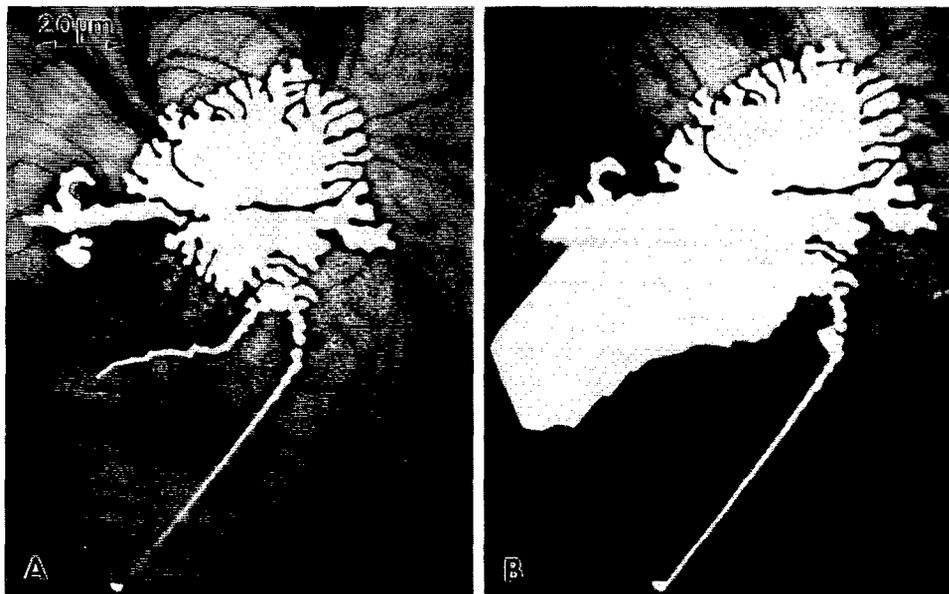
FIG. 1. Low magnification TEM images of sample #3 after (a) two laser pulses at 0.034 J/cm^2 and five pulses at 0.048 J/cm^2 , (b) five more pulses at 0.041 J/cm^2 . The long narrow fingers around the hole (white area) are due to the sample coarsening during thermal annealing. Crack lines are seen in (a) and some areas were cleaved in (b).

Results on sample #3 performed with low power laser pulses after sputtering and thermal annealing are presented first. The only significant change in the material was cleavage along $\{111\}$ planes after repetitive laser pulses. Figure 1(a) is a low magnification transmission electron microscope (TEM) image showing an overview of the specimen

with some crack lines after two pulses at 0.034 J/cm^2 and five pulses at 0.048 J/cm^2 . (Long narrow fingers around the hole were caused by the coarsening of the specimen during thermal annealing.) Figure 1(b) is after five more pulses at 0.041 J/cm^2 showing cleavage in various areas; only one large piece cleaved during the process and other cleavages were more or less on the microscopic scale. [The bend contours in the images appear different due to a slight difference in the sample tilt between Figs. 1(a) and 1(b), as is the case for the later images as well.] Three enlarged areas are shown in Fig. 2. It is quite obvious from Figs. 2(a) (before) and 2(b) (after) that cleavage occurred in narrow parts of the specimen (arrowed) and the two fingers protruding out were broken off. However, it is somewhat harder to explain the sites of the cleavage in the two areas shown in Figs. 2(c), 2(d), and 2(e), 2(f). The cleavages in Fig. 2(d) are not from the narrowest part of the region and a small finger was left behind. In Fig. 2(f), the cleavage did not occur at the stacking fault [indicated by the arrow in Fig. 2(e)] as might be expected, but at a point where no defect could be seen. During the experiment, dislocations in the sample were not disturbed by the laser pulses.

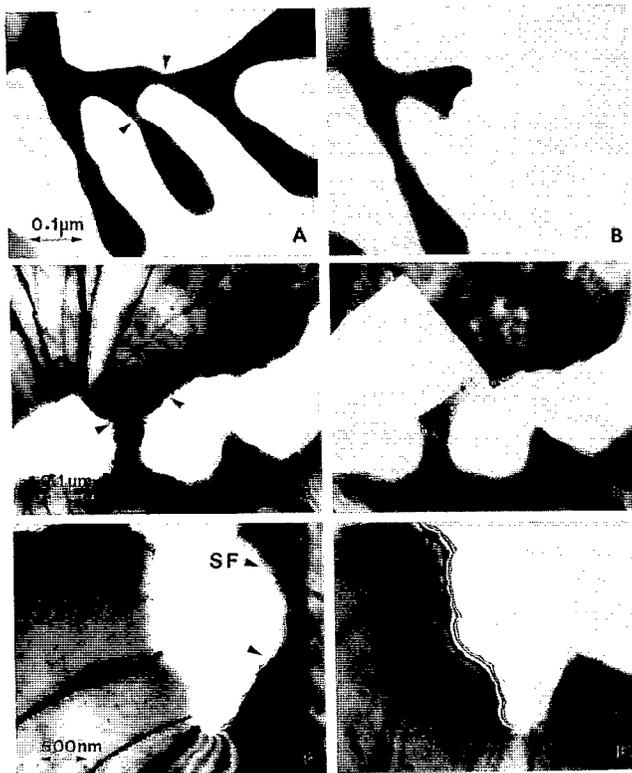
FIG. 2. TEM images showing three enlarged areas of Fig. 1(a), [(a), (c), (e)], and Fig. 1(b) [(b), (d), (f)] of sample #3. The arrows in (a), (c), and (e) indicate the locations of the cleavages. Also in (e) an arrow points to a stacking fault above the cleavage line.
